**Subject:** **Catch Basin Sampling**  
Aqueous and Sediment Sampling  
Rainier Commons, LLC

**Site Address:** 3100 Airport Way S, Seattle, WA

NVL Project#: 2012-494

## Attachment B: Site Observation Photos

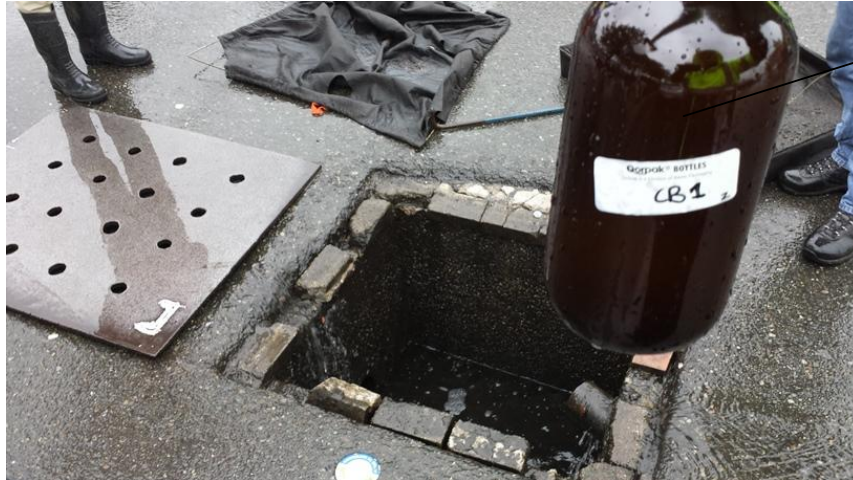
**Catch Basin 1**  
Adequate water for sampling was found in catch basin 1. Sediment levels were found to be inadequate for sampling.

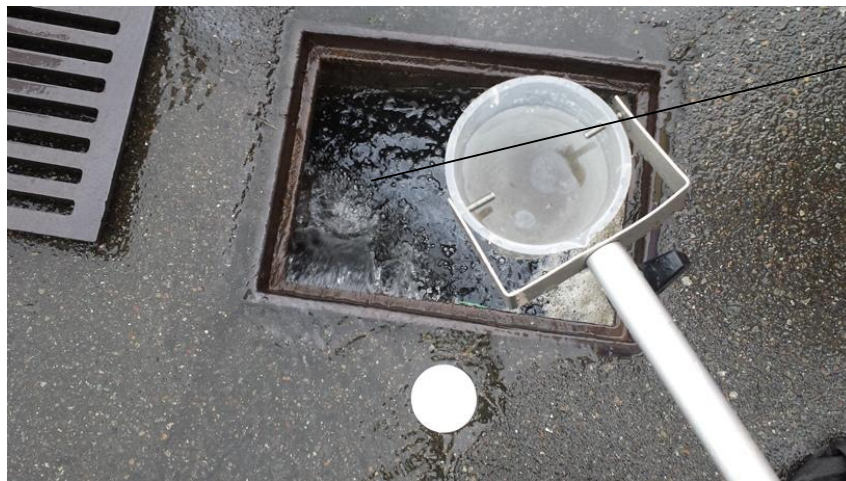
**Catch Basin 3**  
Adequate water for sampling was found in catch basin 1. Sediment levels were found to be inadequate for sampling. The disposable sampling cup and telescoping wand used for sampling are seen here.

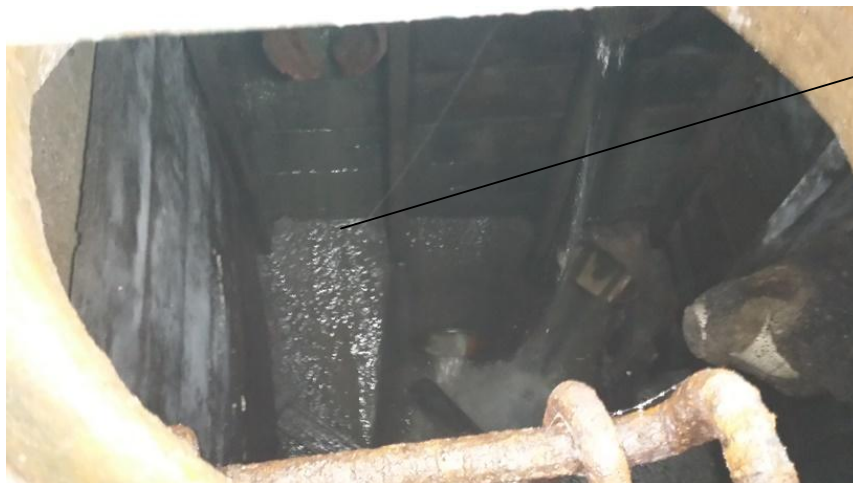
**Manhole 6**  
Inadequate sediment for sampling was found in manhole 6. Adequate water was present and an aqueous sample was collected here.
